Sidewalk Inventory Findings

The Big Picture

Sidewalks Inventory Findings

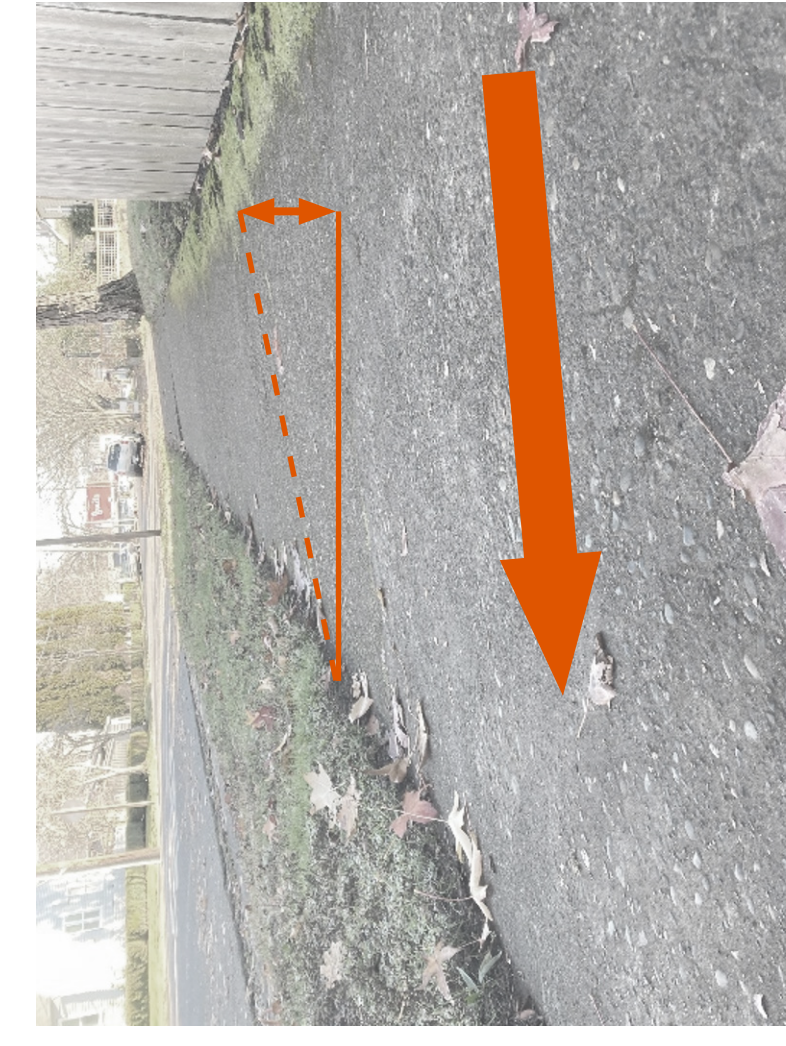
Cross Slope is perpendicular to direction of travel.

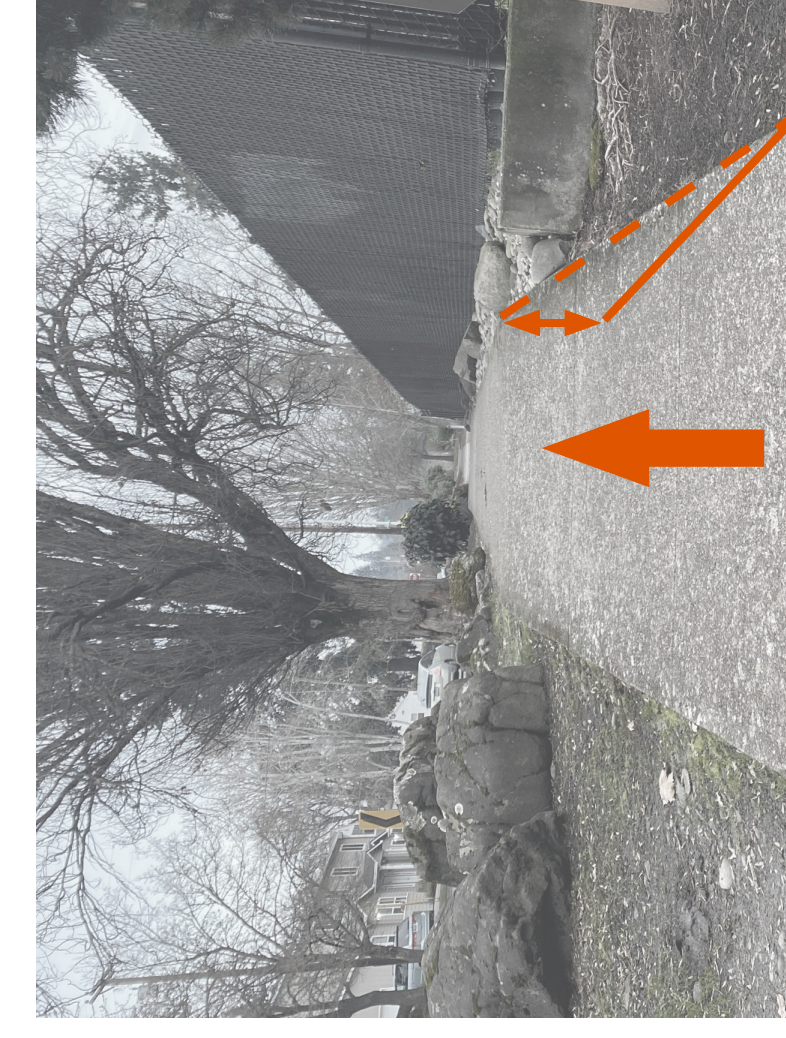
Running Slope, or grade, is in the direction of travel.

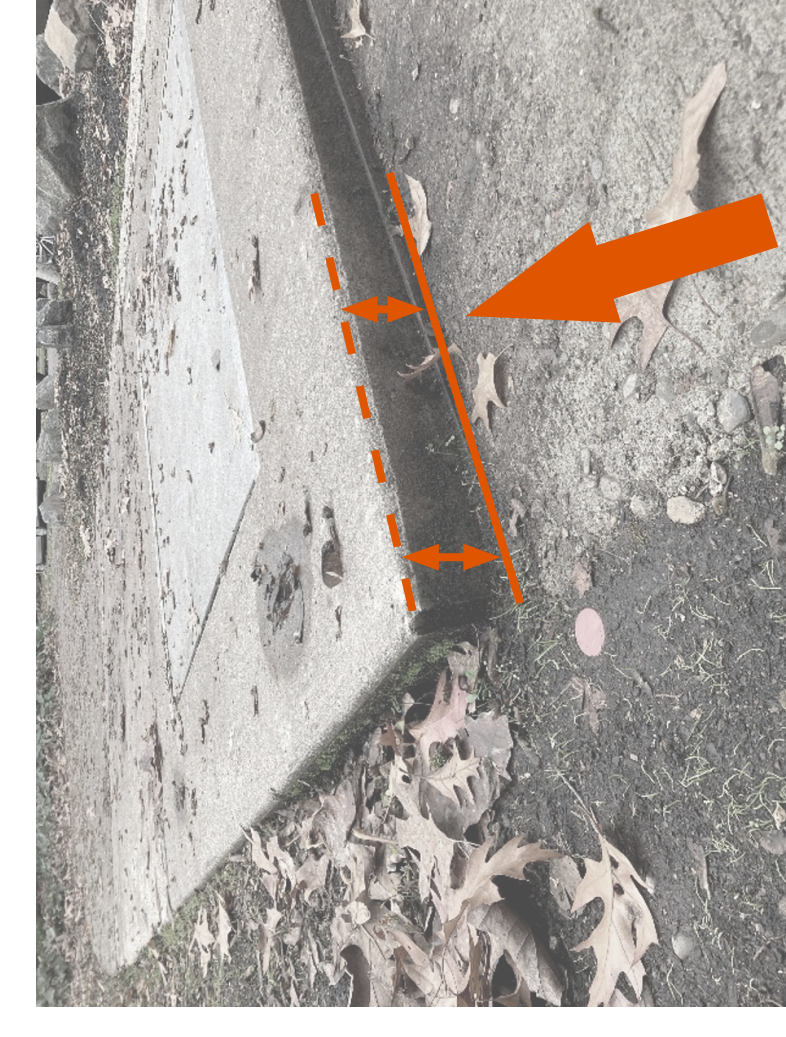
Uplift is a height difference where two pavers meet.

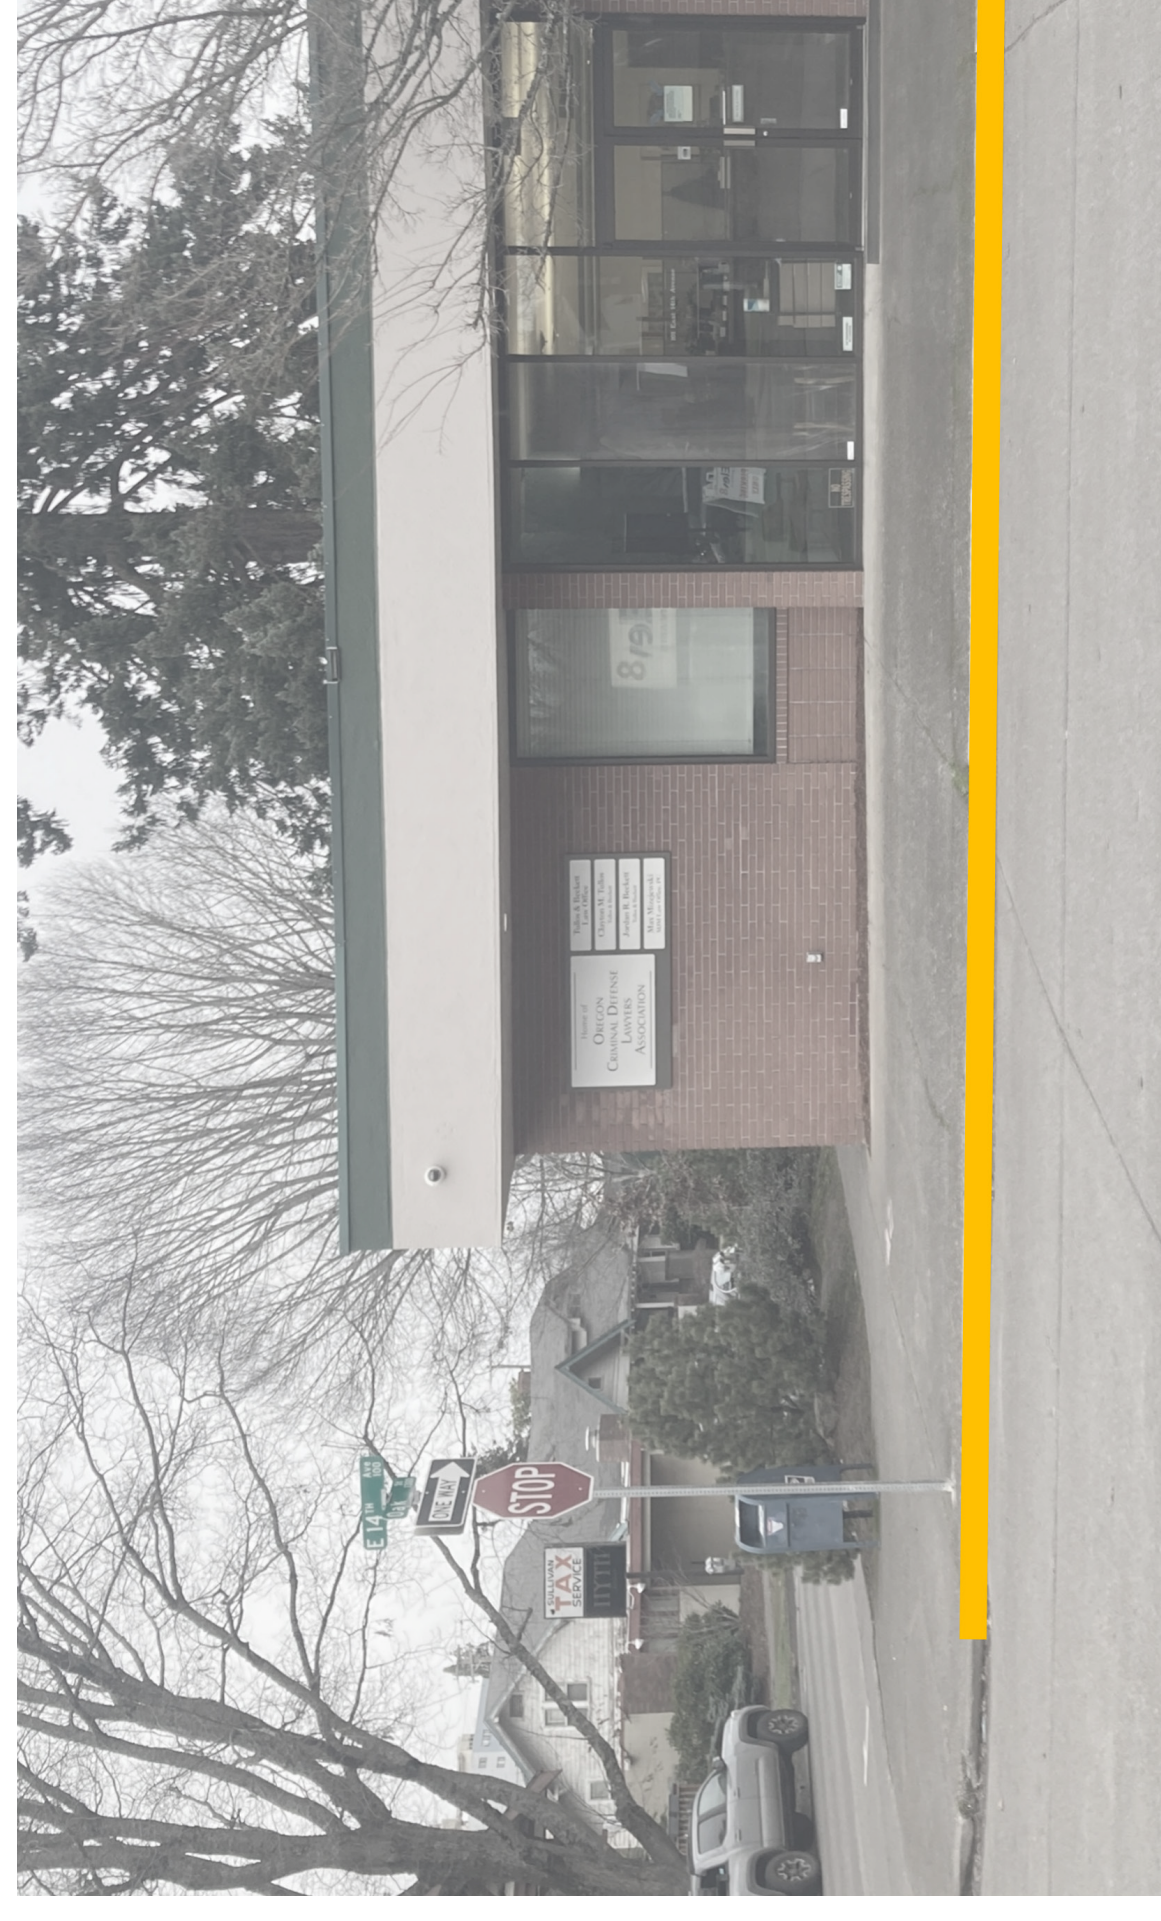
The yellow line at left is a **Parking Restriction on Crosswalk** approach and is the only thing protecting the crosswalk for you to cross while visible to drivers!
