Sidewalk Inventory Findings

The Big Picture

Sidewalks Inventory Findings

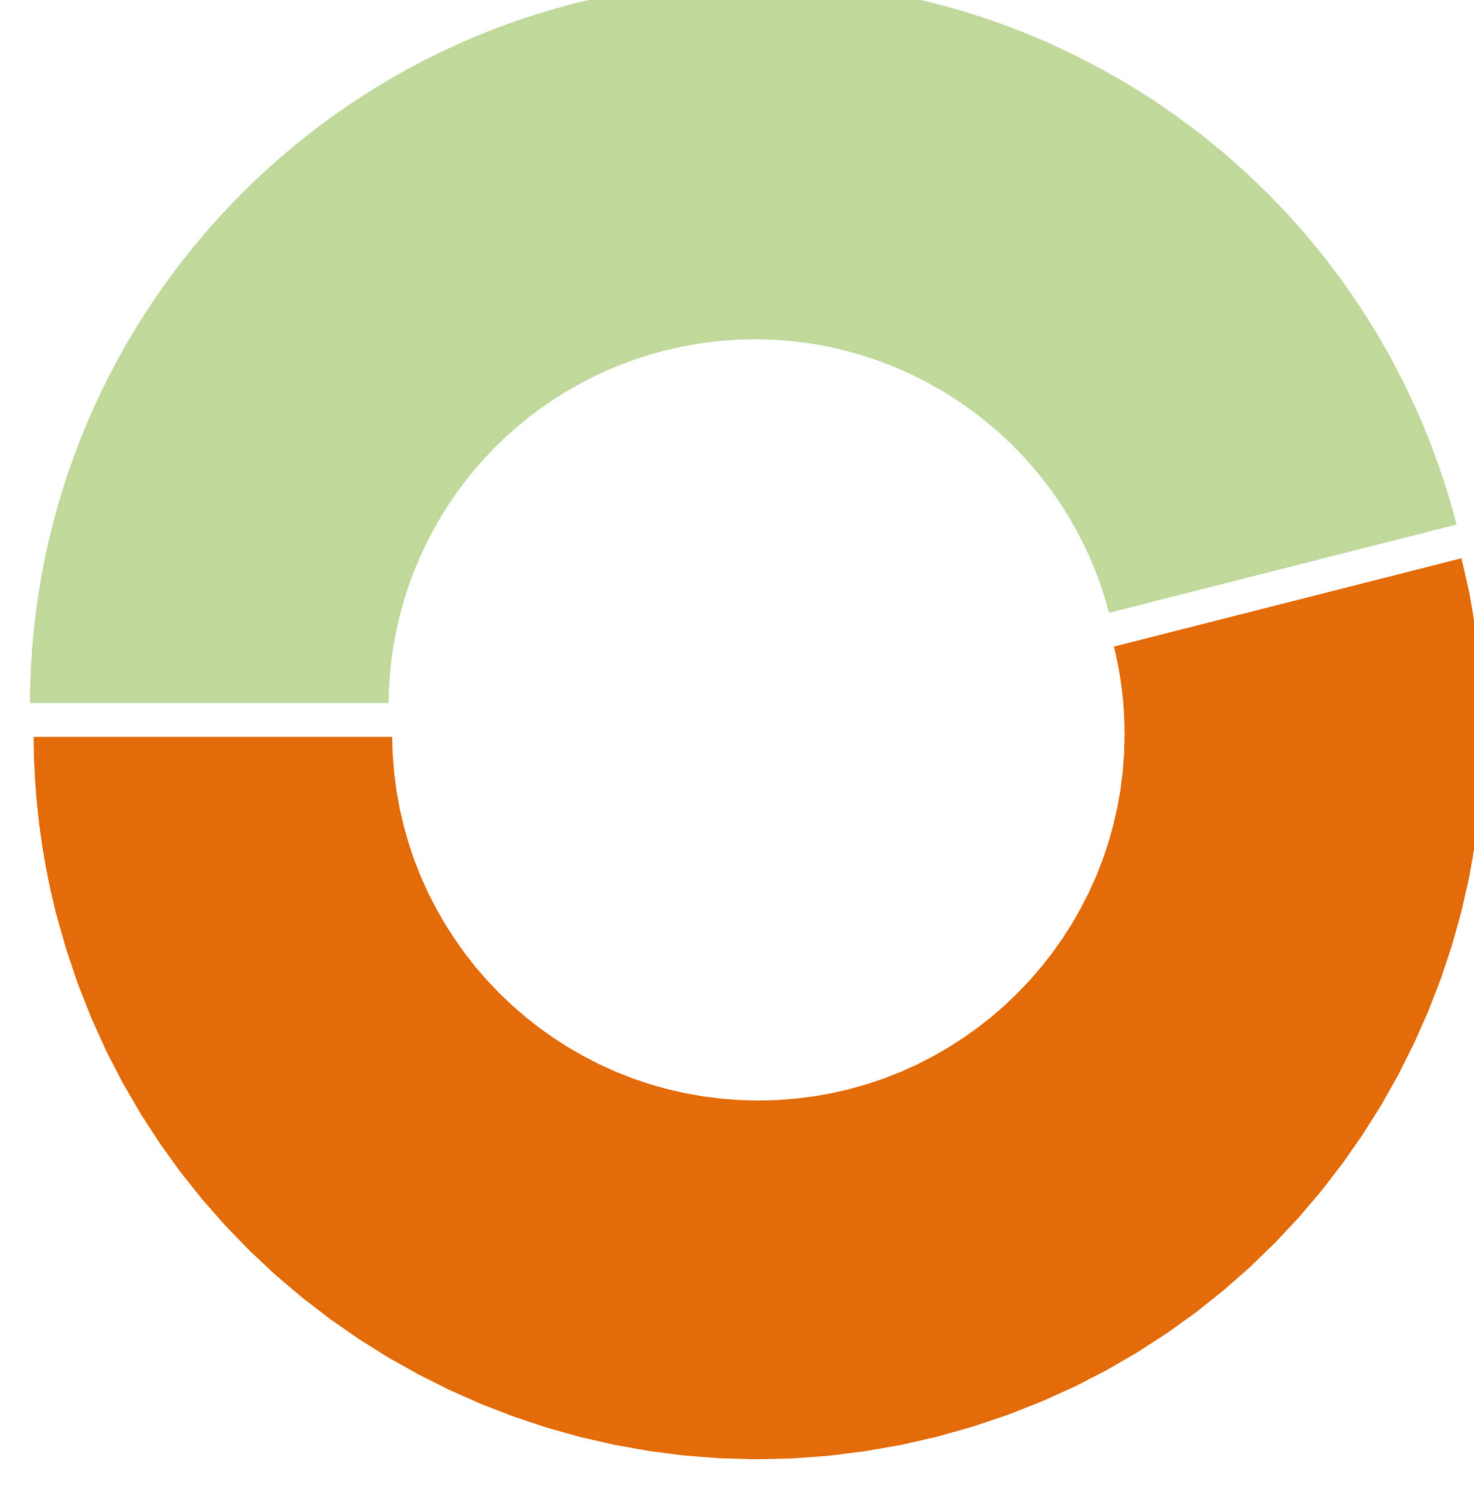
Over 50% of the sidewalks surveyed were ADA Non-Compliant in some way

The green bar above represent square footage that is "Perfect/Very Good," "Good," or "Moderate" and is otherwise ADA compliant.

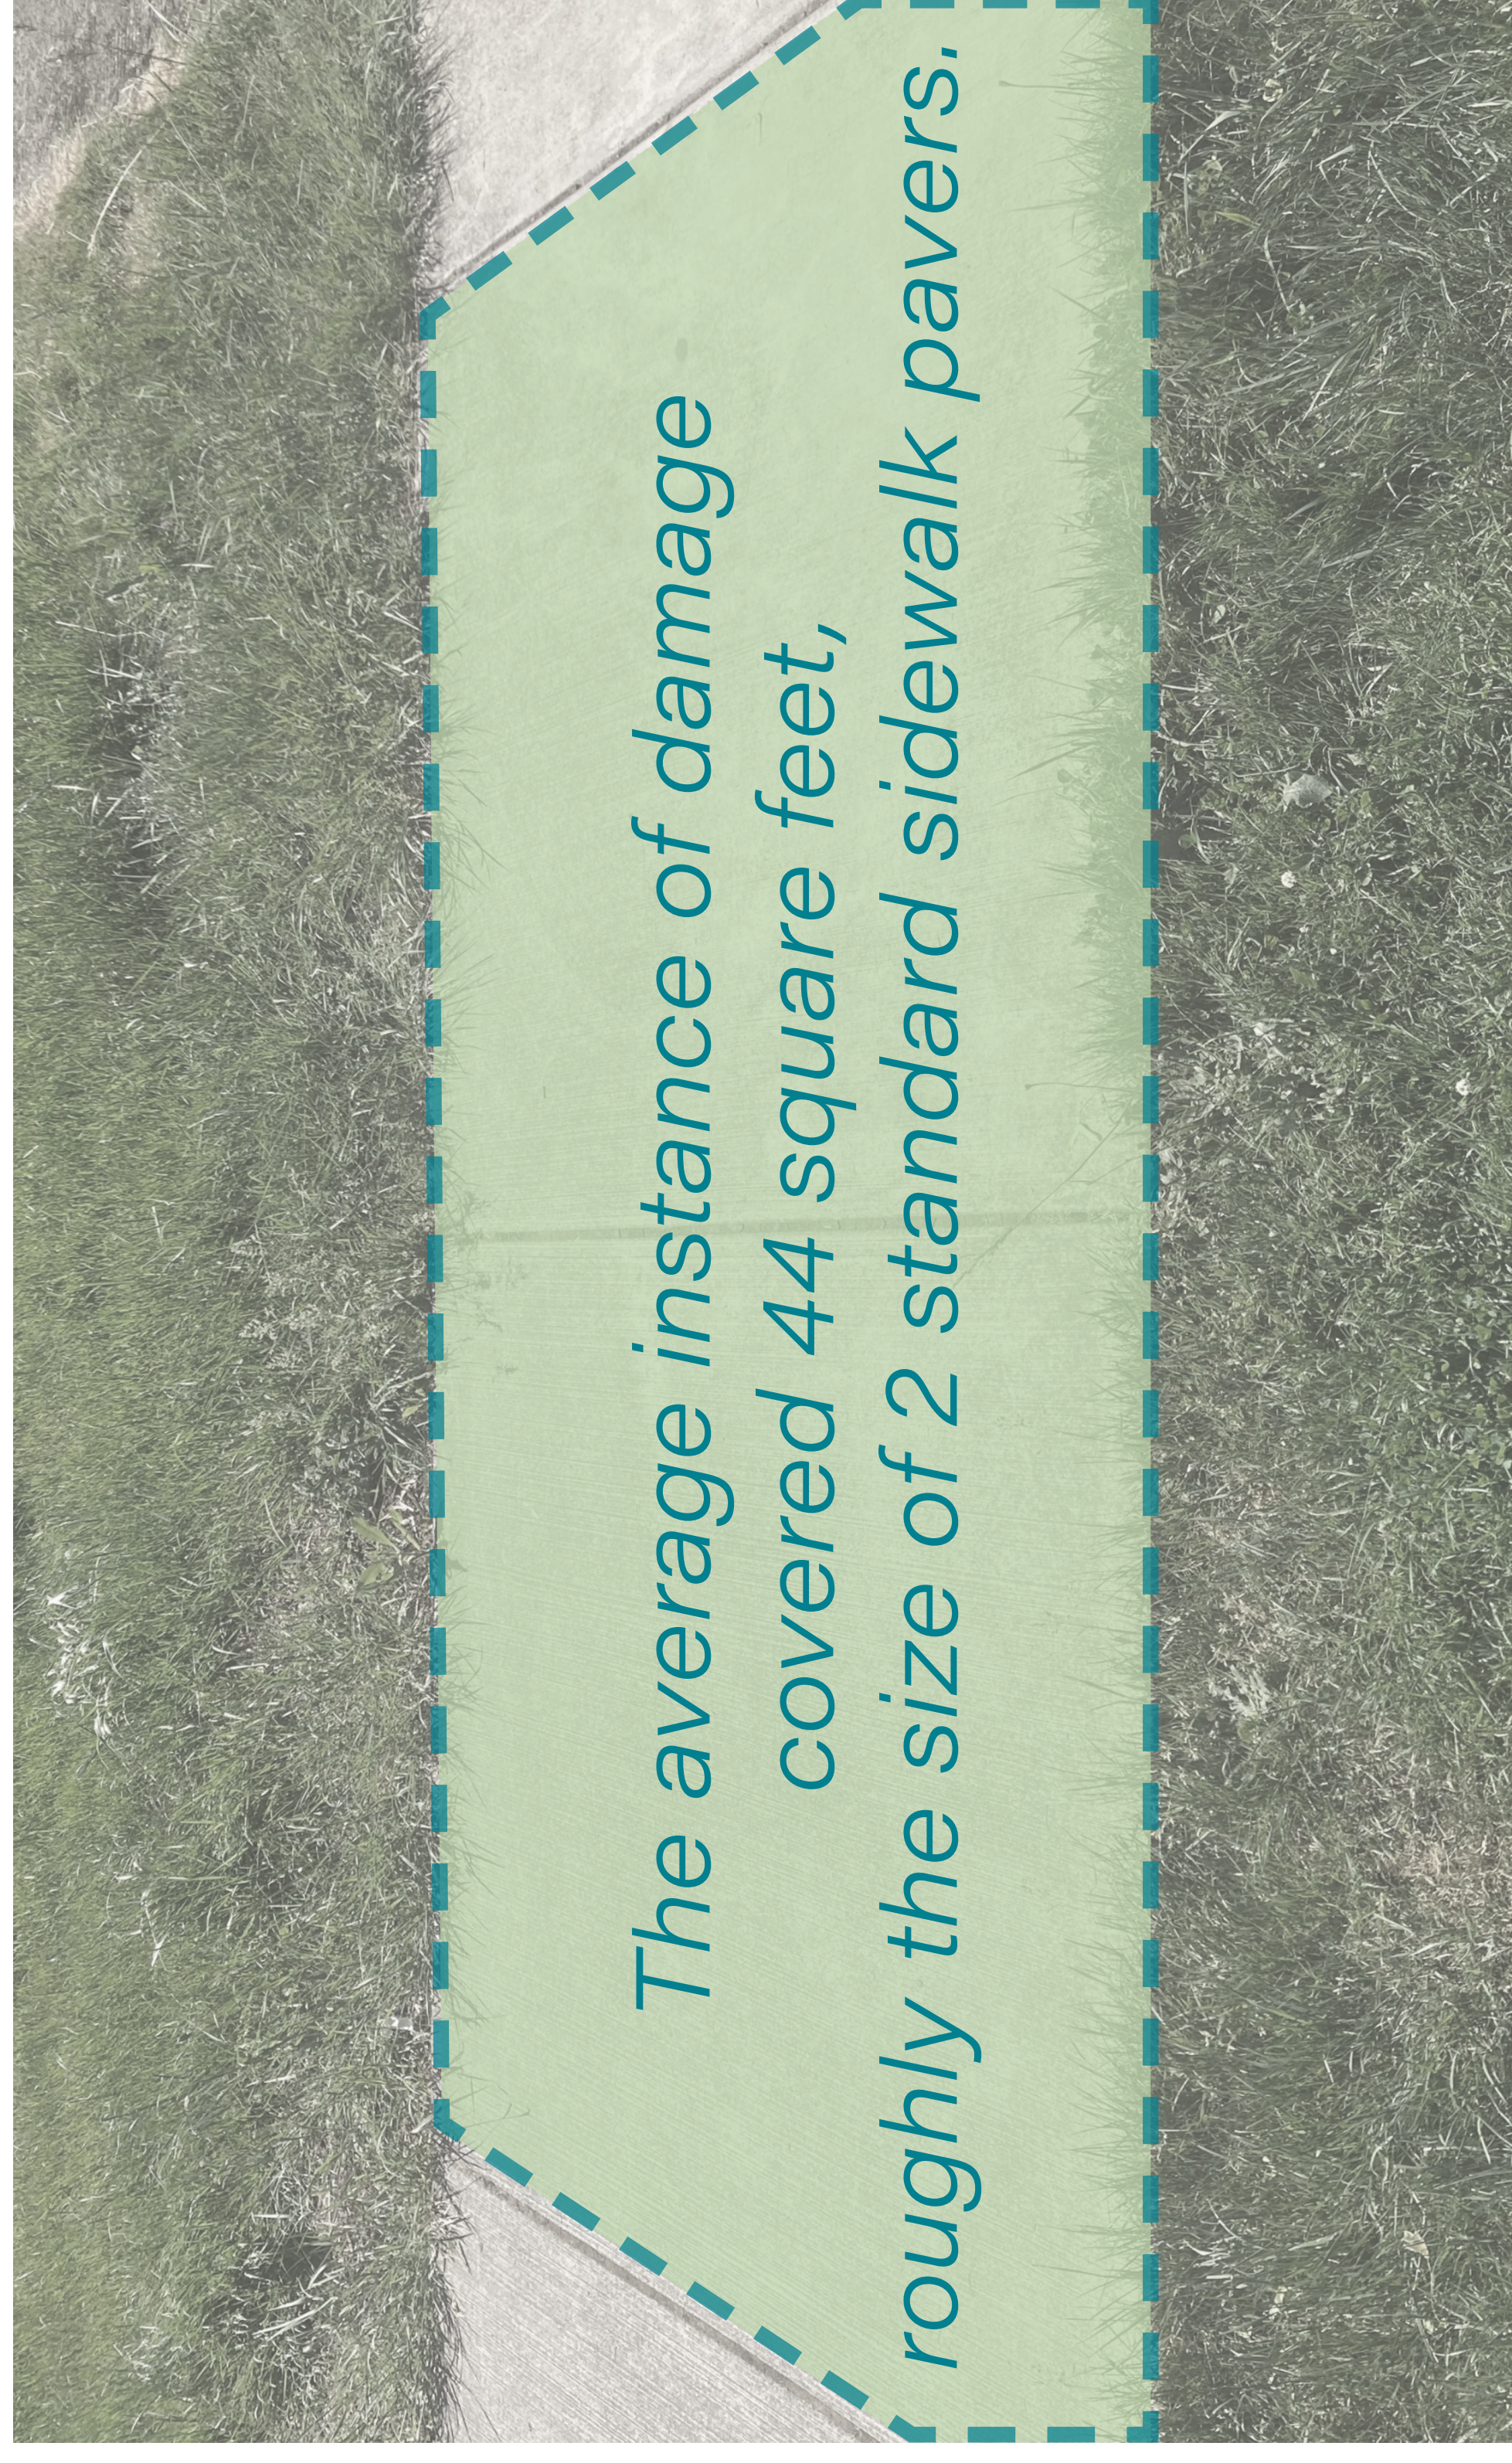
In general, the **EXTENT** of the damage increased as the **SEVERITY** of the damage increased. This tells us that small issues effecting individual pavers could become larger issues effecting a larger area as the pavers deteriorate.

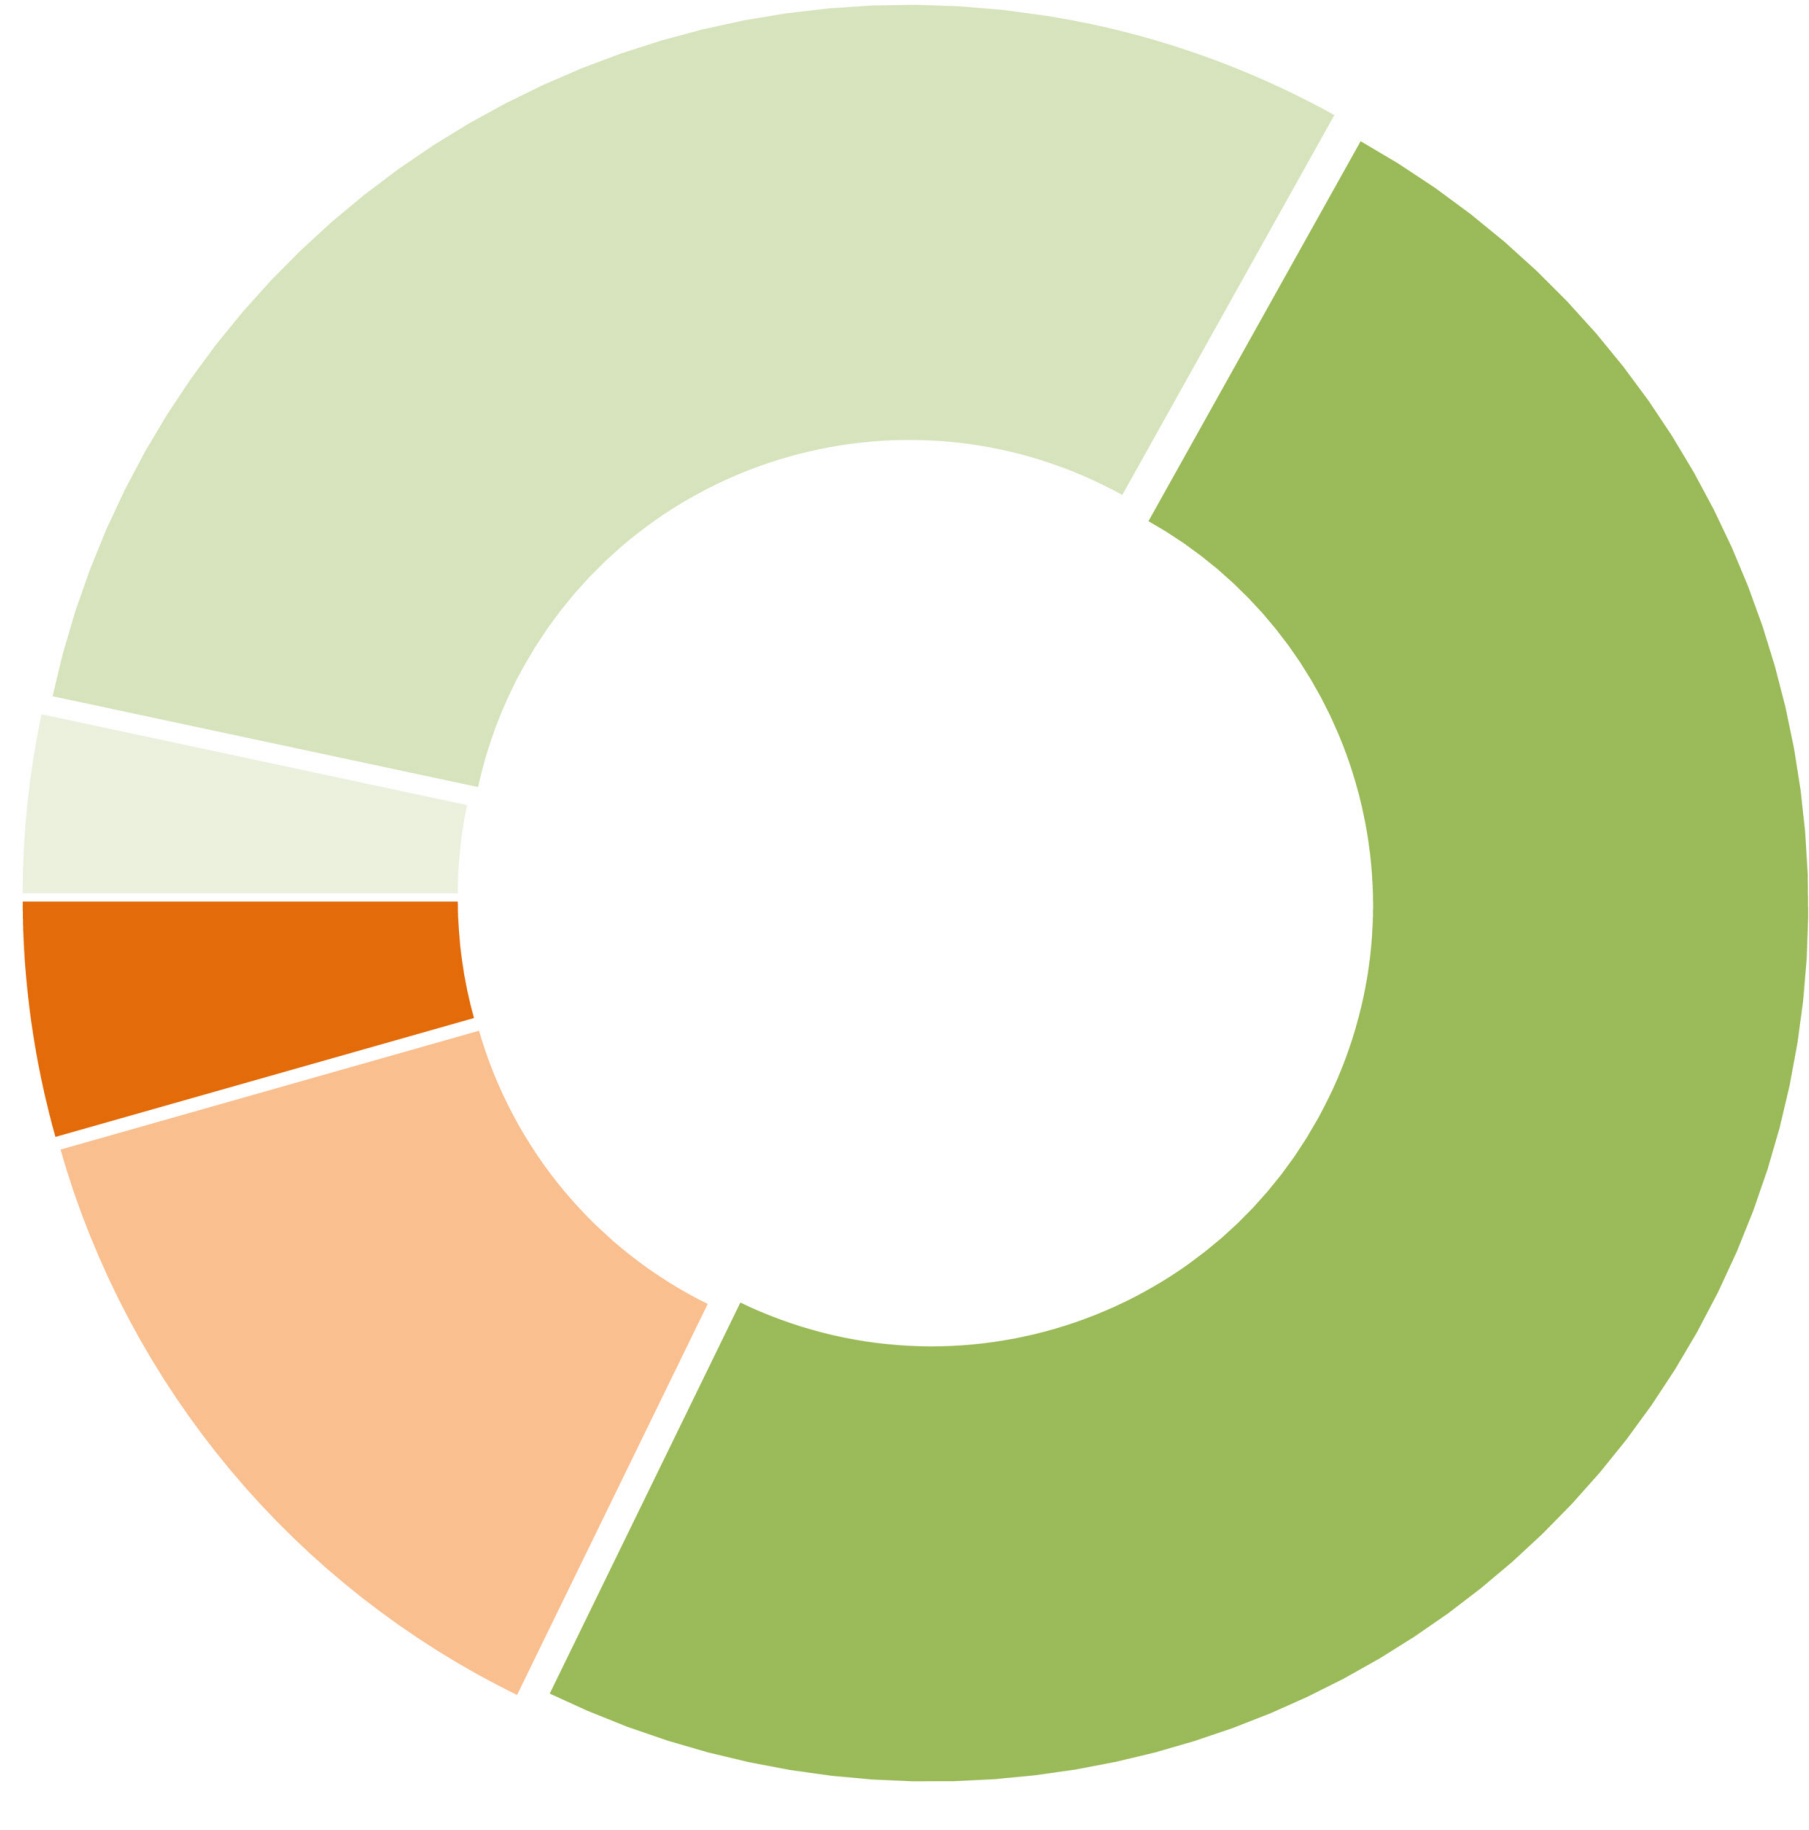
Approximately **50%** of recorded Square Footage was assessed as 'Moderate'

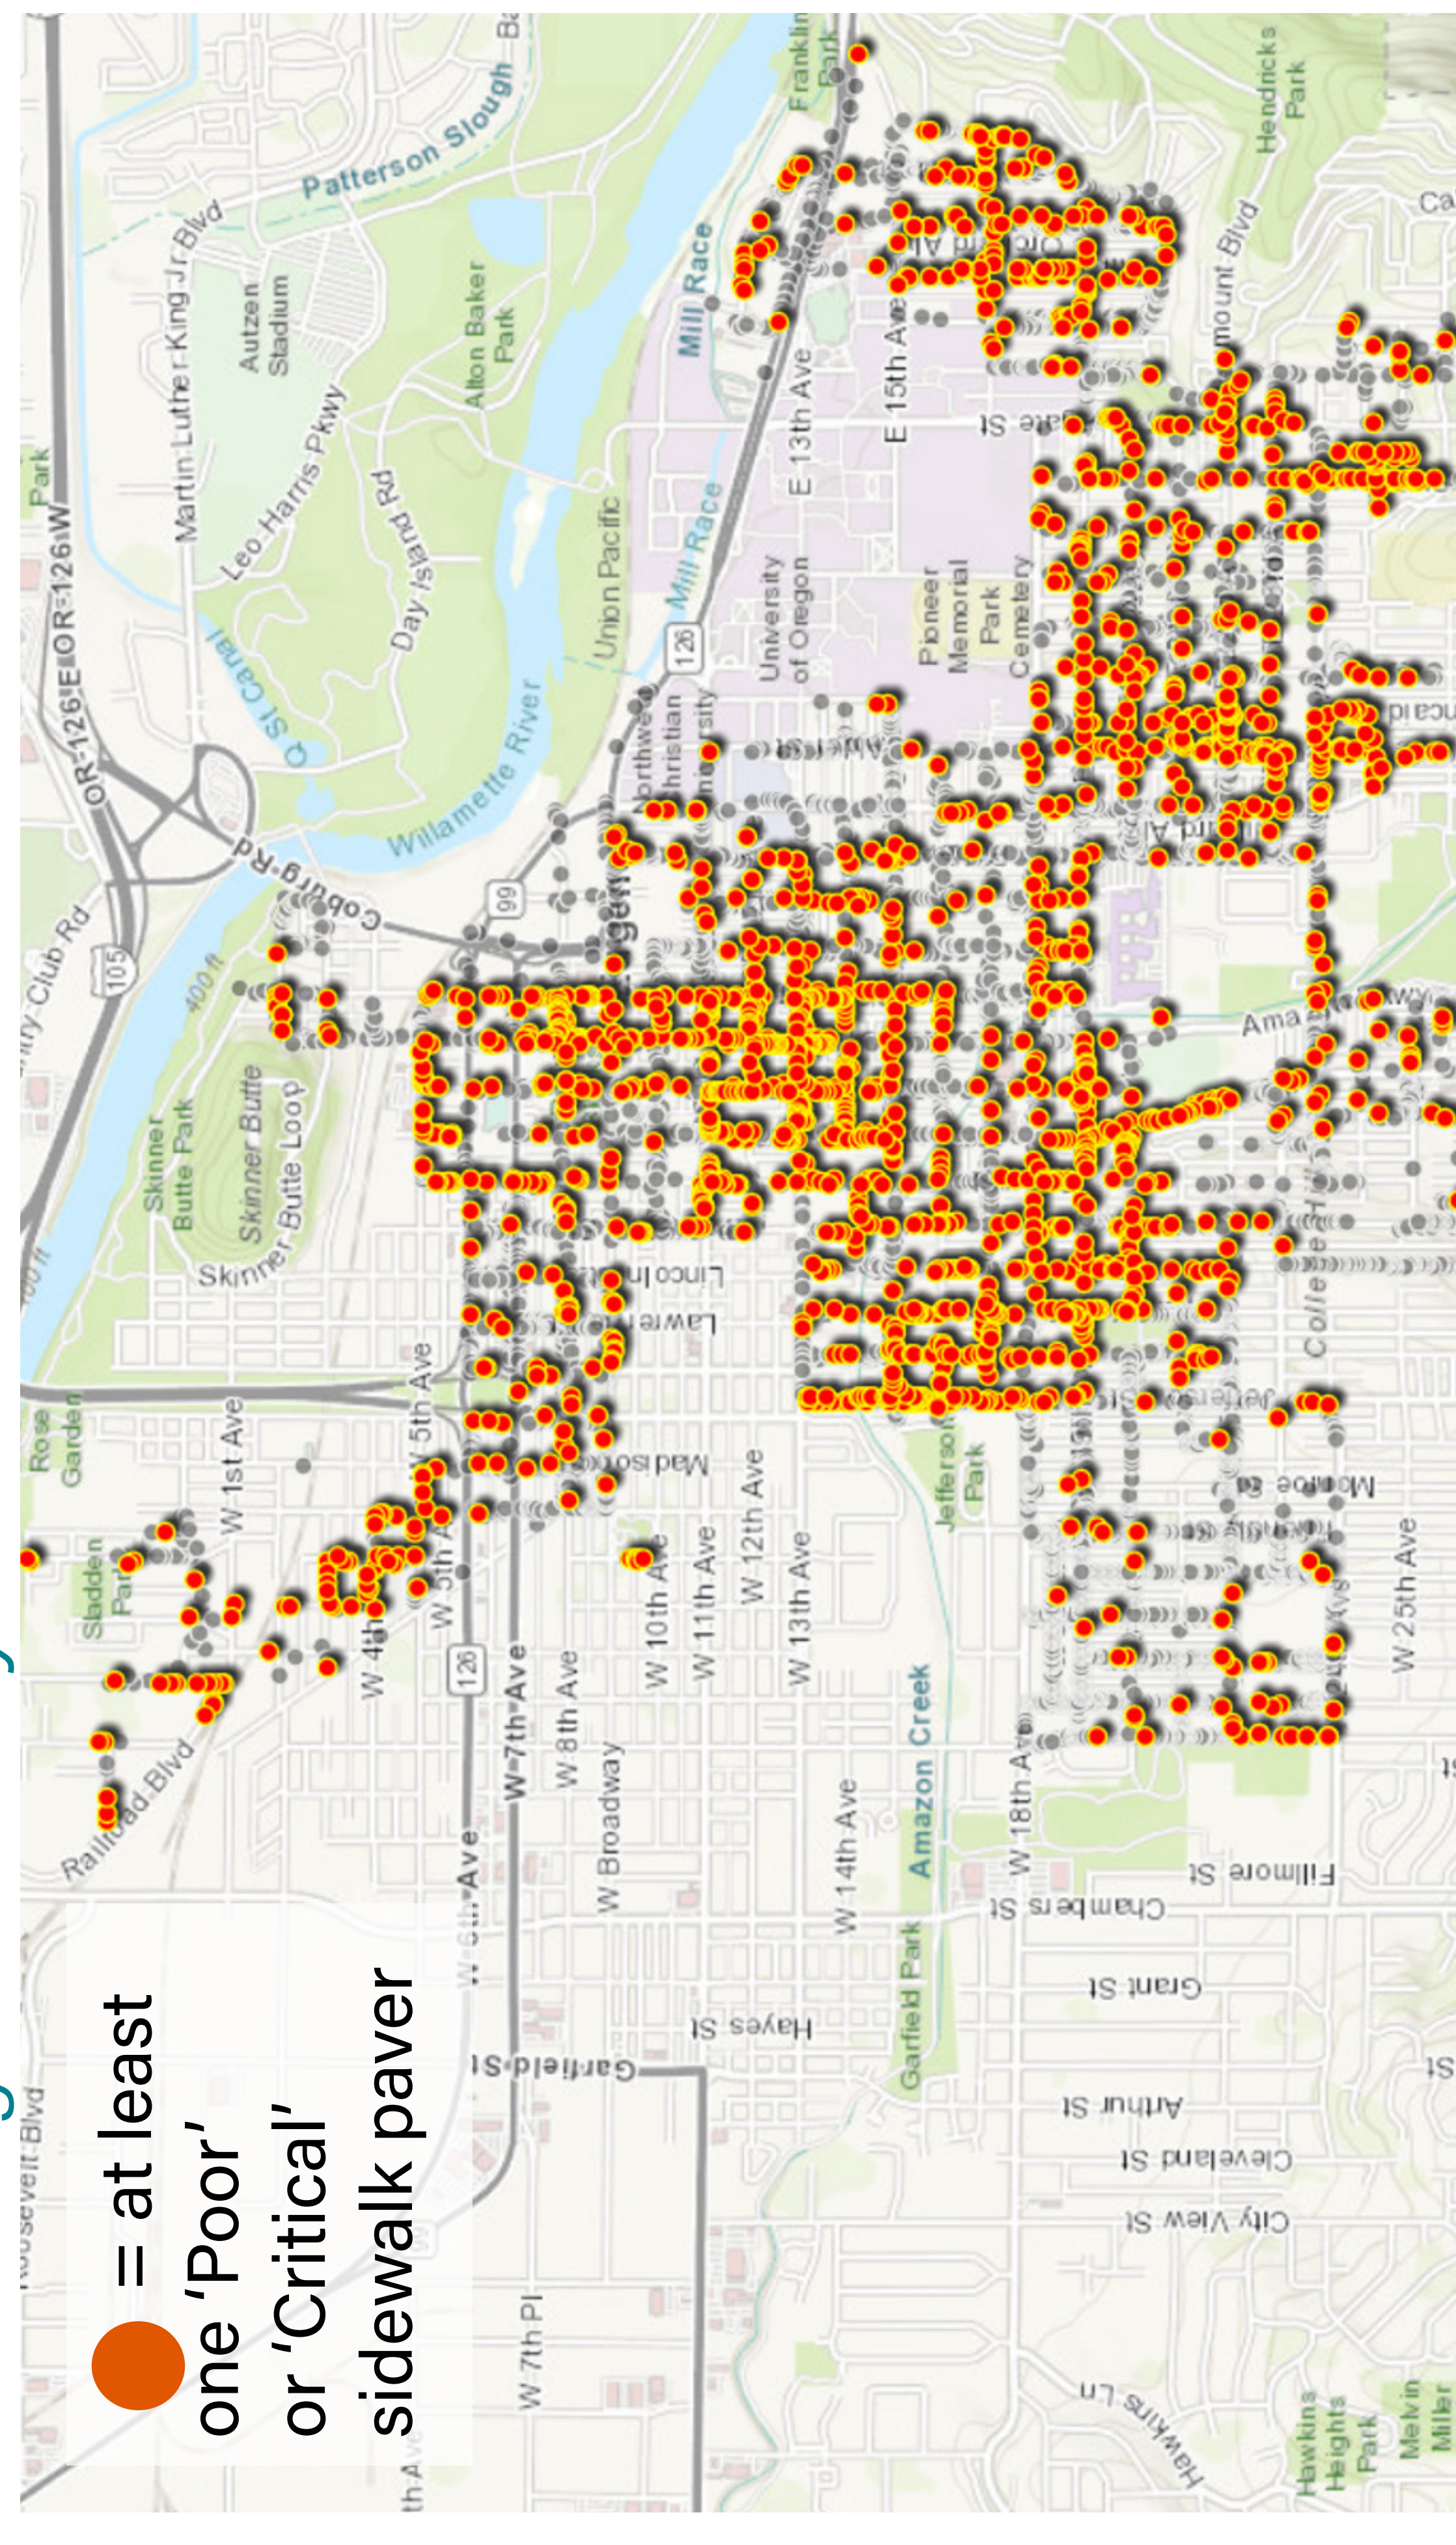
...But 'Poor' and 'Critical' pavers, some indicating severe damage, can be found throughout the city.

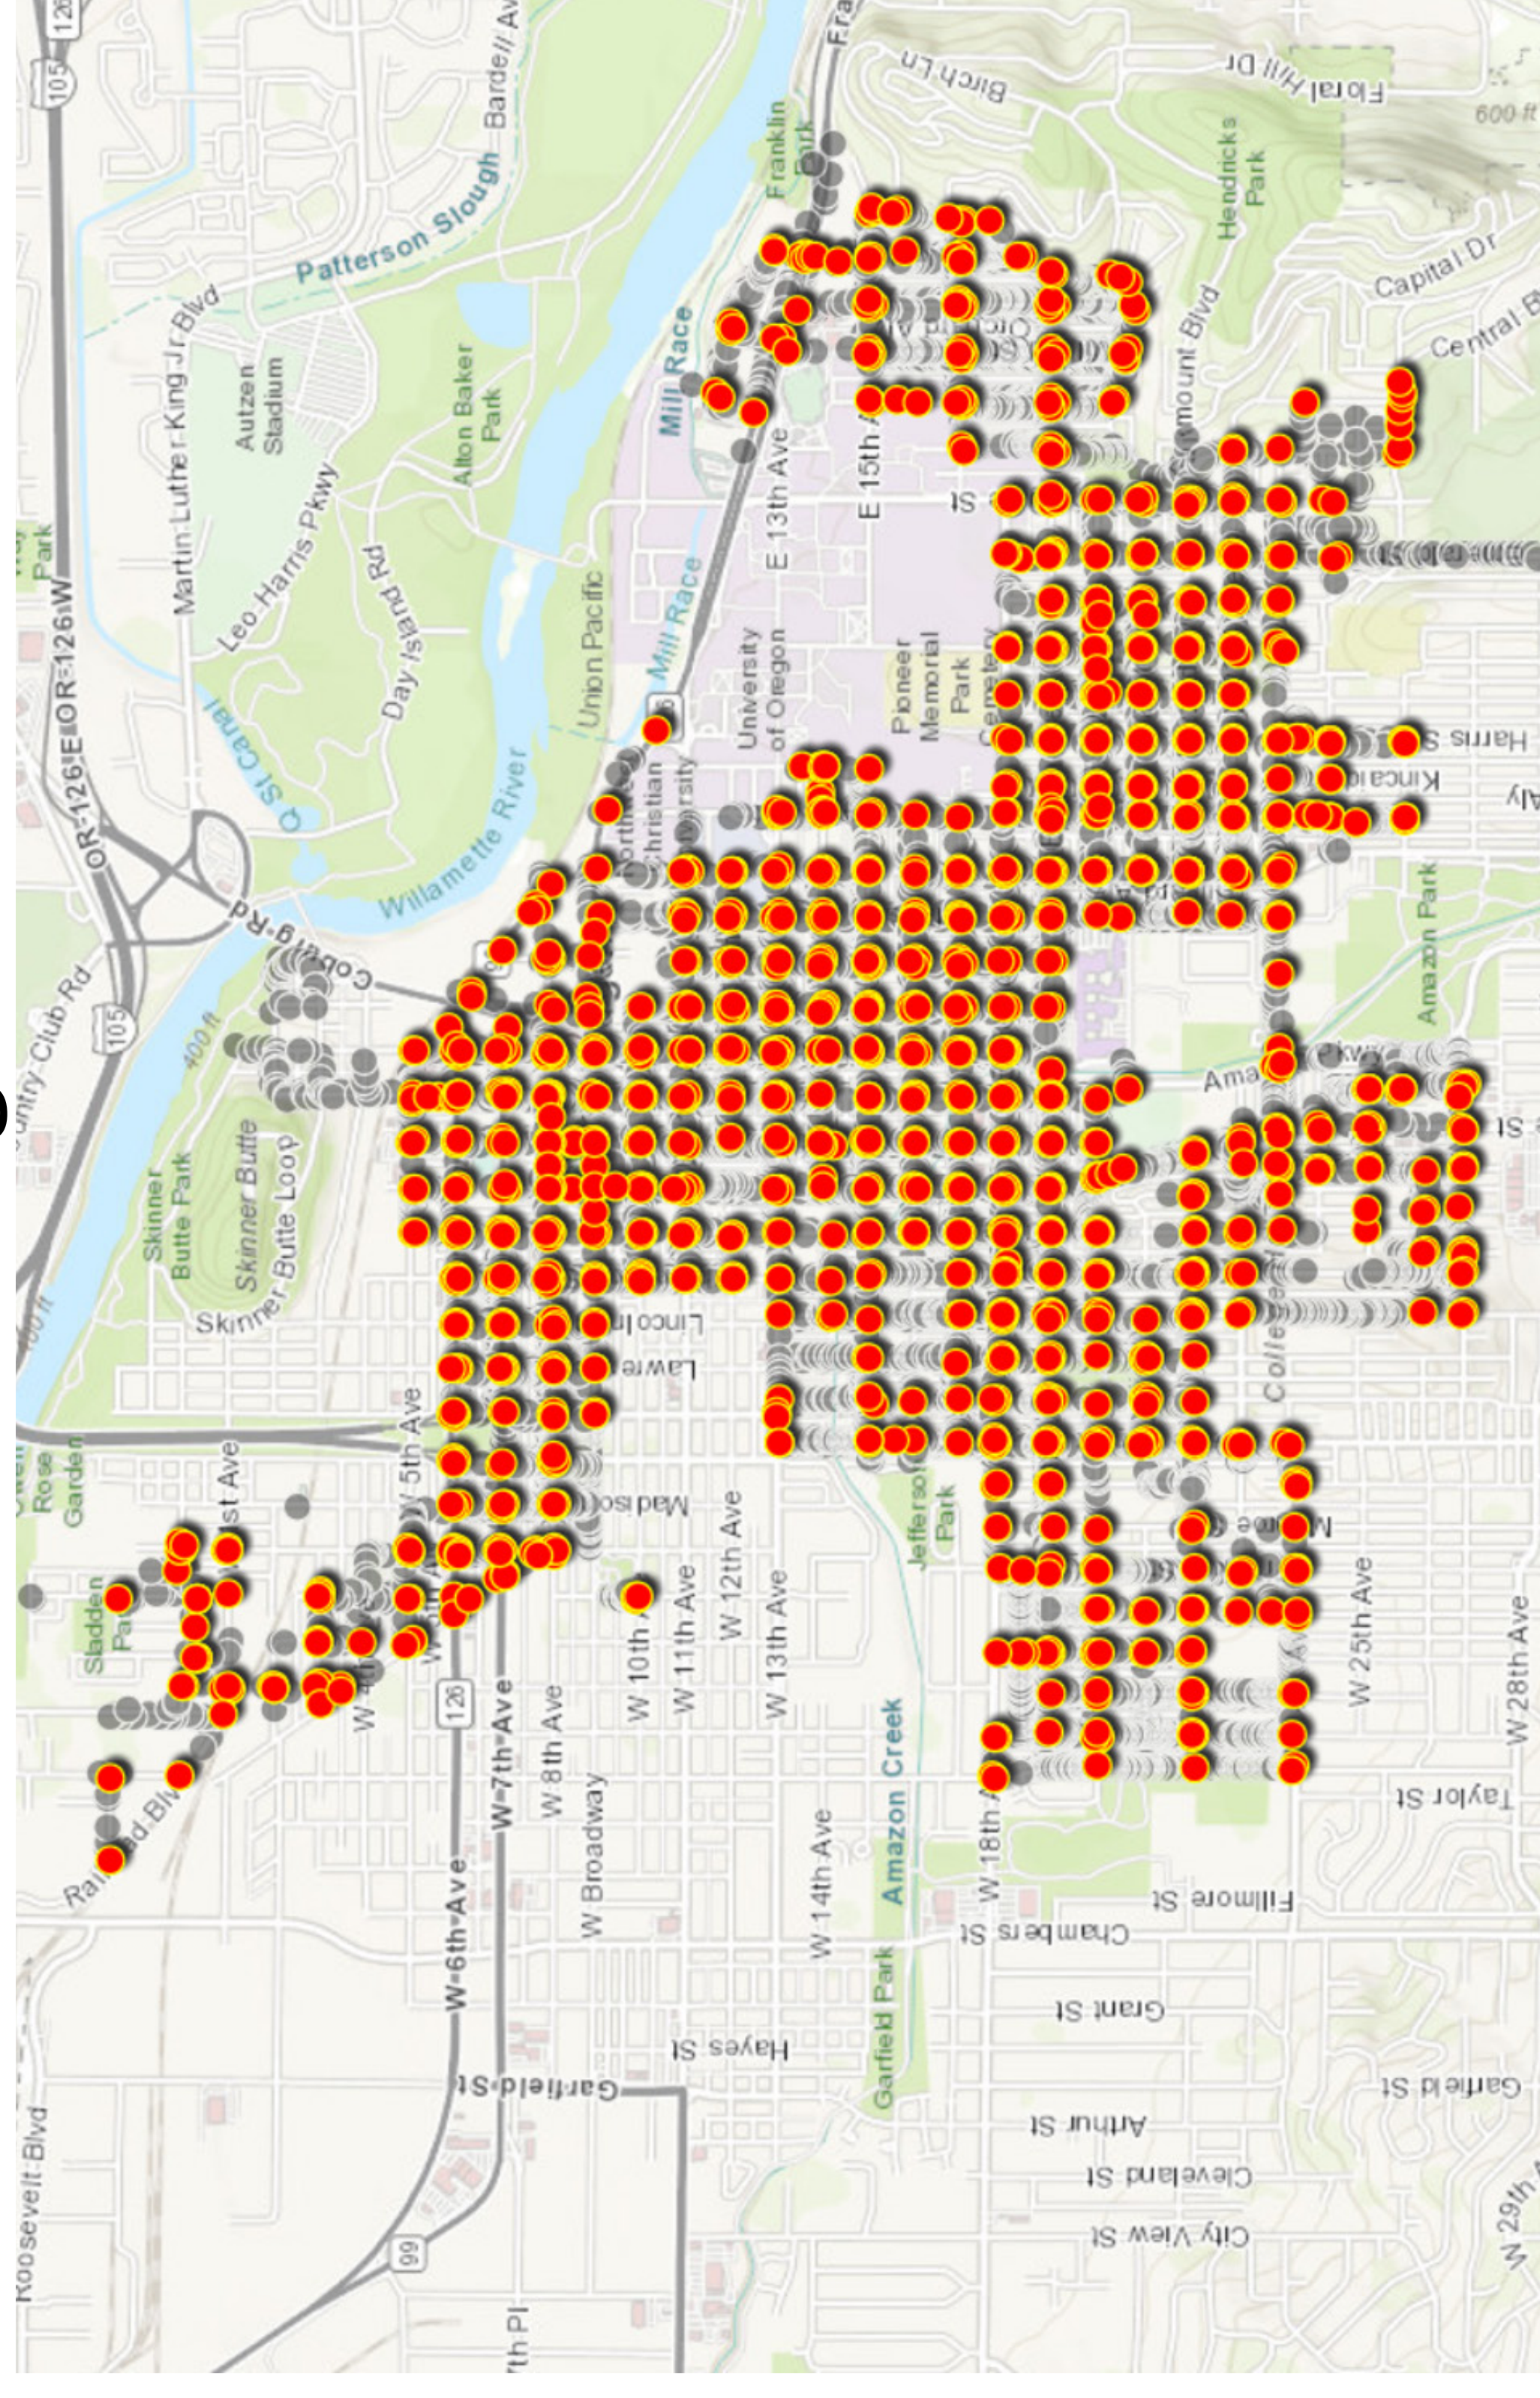
At Least One Crossing Treatment

Of the area surveyed, many curb cuts had **SOME** kind of treatment to protect or otherwise encourage pedestrian crossings, however...

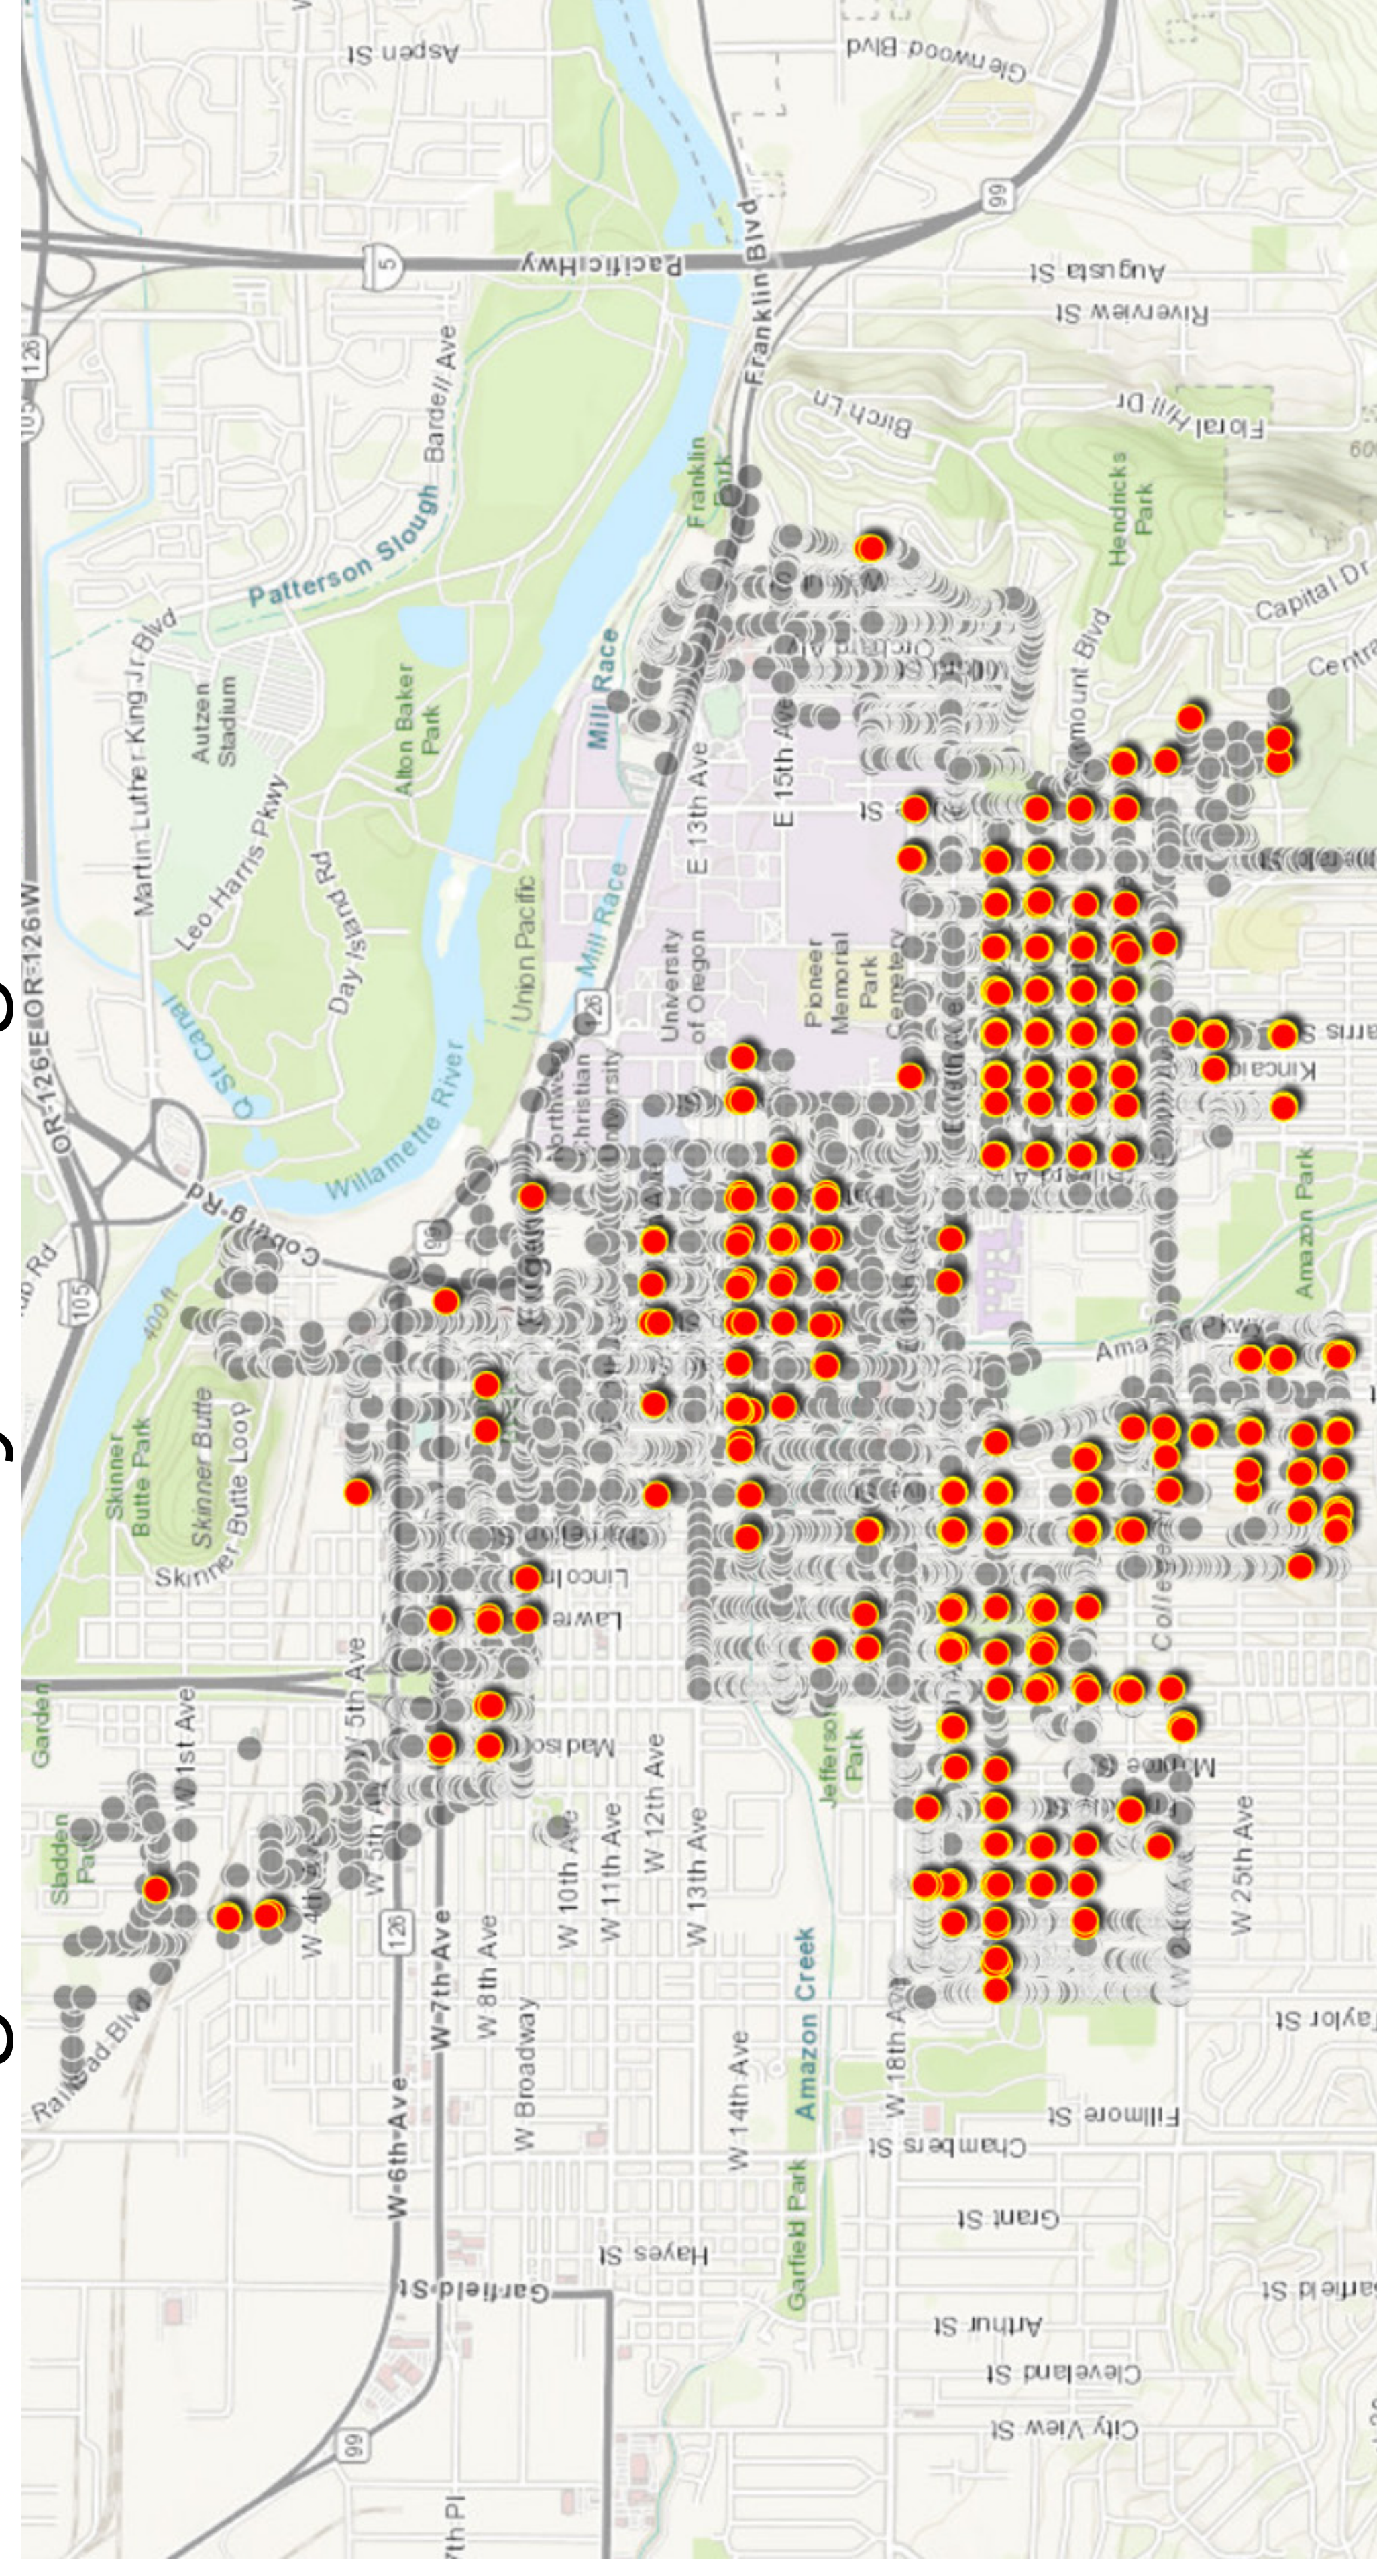
Crossings With Only Parking Restrictions

Over 300 crossings had **ONLY** Parking Restrictions, meaning no signage, stop lines, or crosswalk paint, including across busy roads like Patterson & Hillyard.
